Skive detect inspection system for global pharmaceutical company.

Case Study

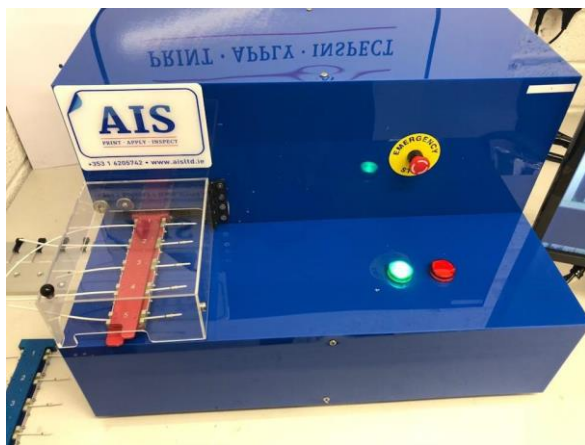
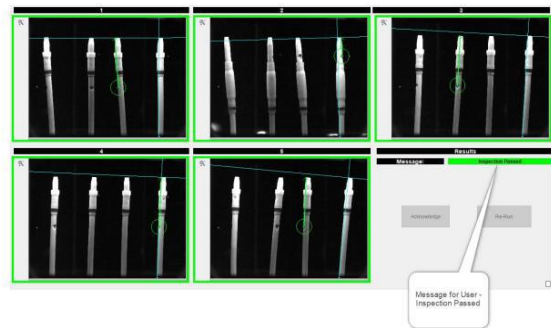
The AIS 360 Inspection System consists of:

- **A Polyview Lens** which is an integrated optomechanical system to inspect and measure parts from the side without any need for rotation.
- **Datalogic MX-E20 Processor**
- **Datalogic IMPACT Software**
- **Datalogic M-Series Camera**

The hardware along with the movable cassette is housed in a robust enclosure which is linked to a touchscreen display screen which clearly tells the operator if the inspection has passed or if errors were detected.
